LETTER REPORT
FOR
PR MALLORY SITE
CRAWFORDSVILLE, INDIANA
TDD#: T05-9210-112
PAN#: EIN0788RBA

June 20, 1994

RE: PR Mallory site
Crawfordsville, Indiana
TDD#: T05-9210-112
PAN#: EIN0788RBA

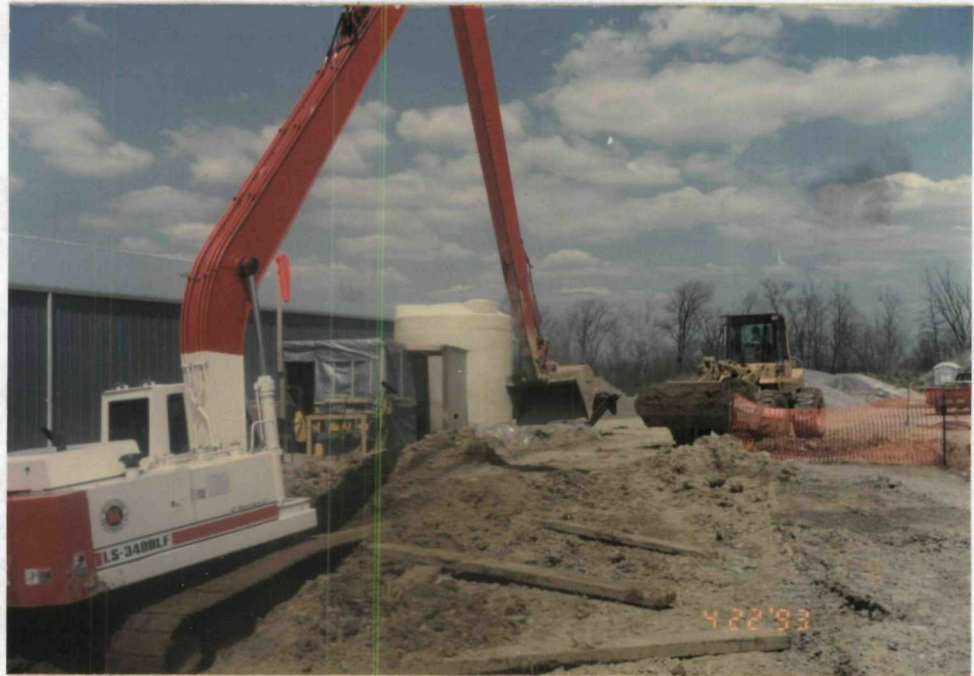
DESCRIPTION: Preparing loading ramp for trailer trucks to back
down during loading.

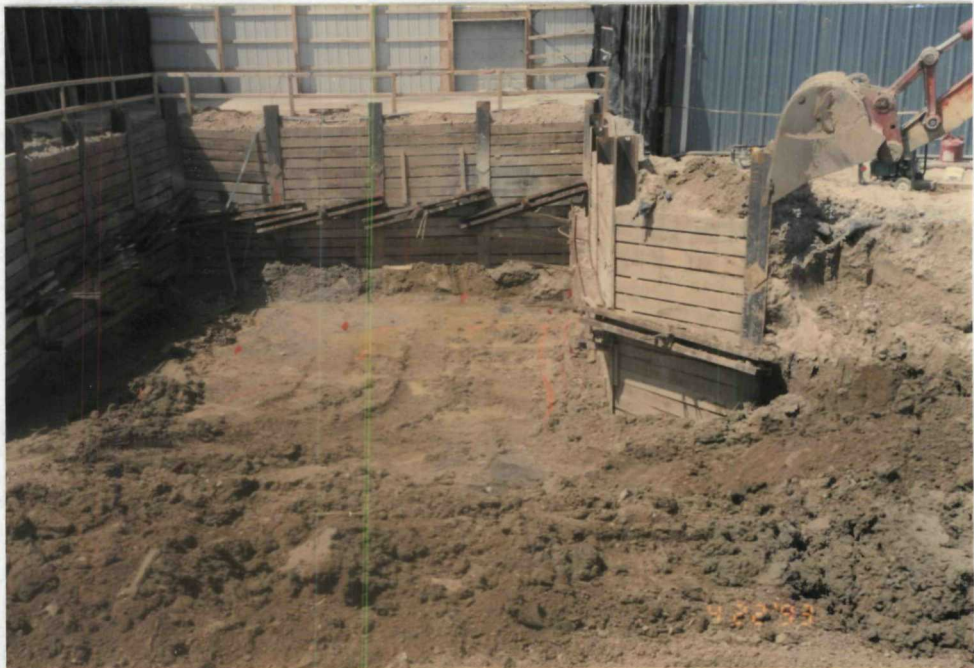
DESCRIPTION: Contaminated area marked off beneath dismantled
portion of Terra building.

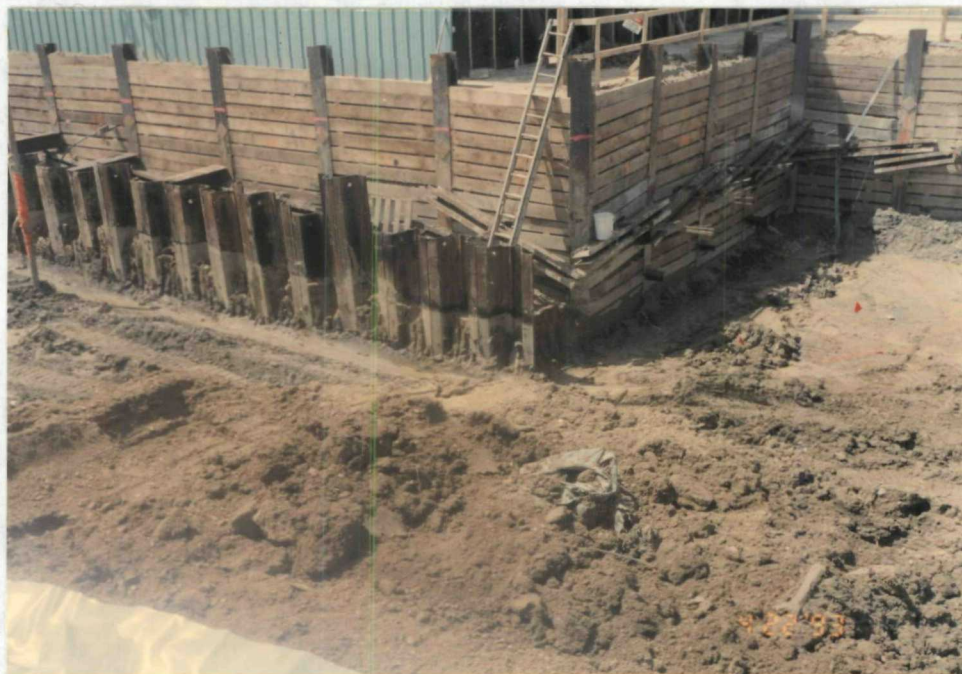
DESCRIPTION: Overview of both contaminated areas: area to right is beneath dismantled building; area to left is southern limits of contamination.

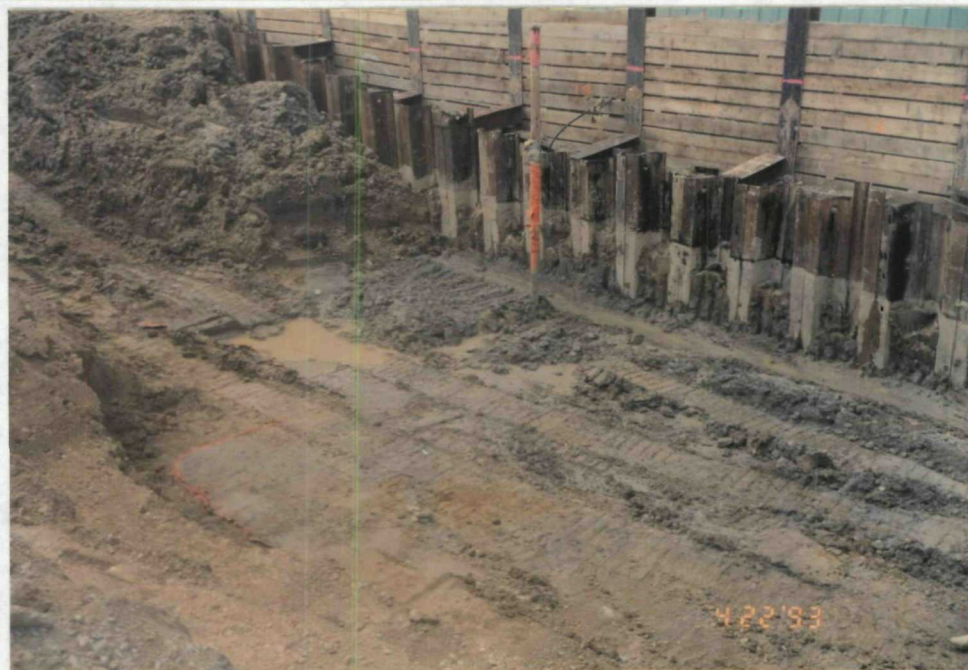
DESCRIPTION: Closeup of southern most contaminated area.

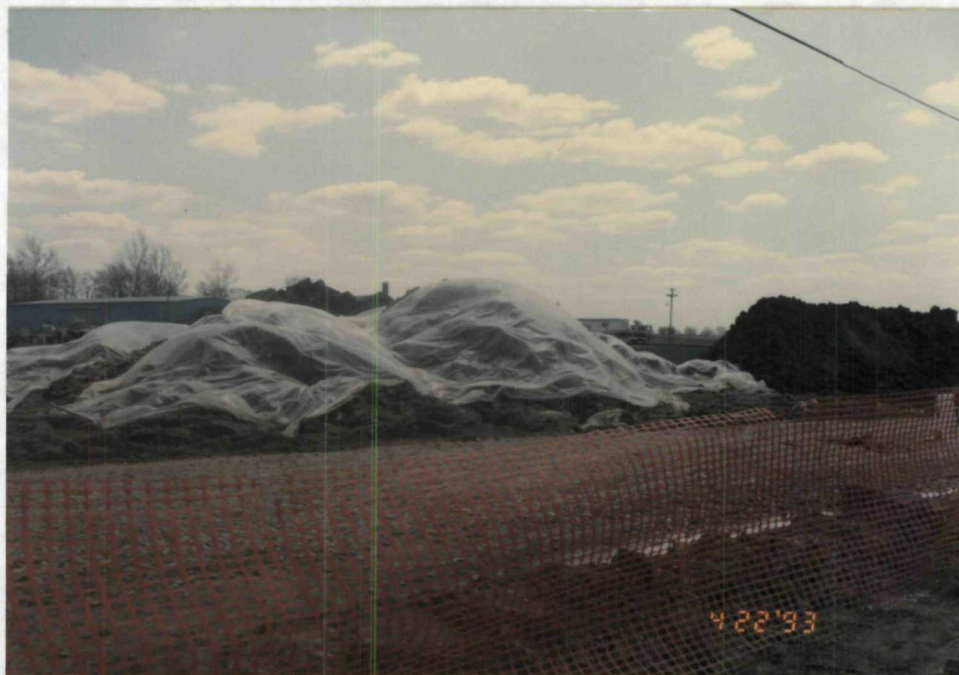
DESCRIPTION: Overburden stockpiles north of excavation pit.

Covered piles have been tested for PCBs; uncovered piles will be
tested.

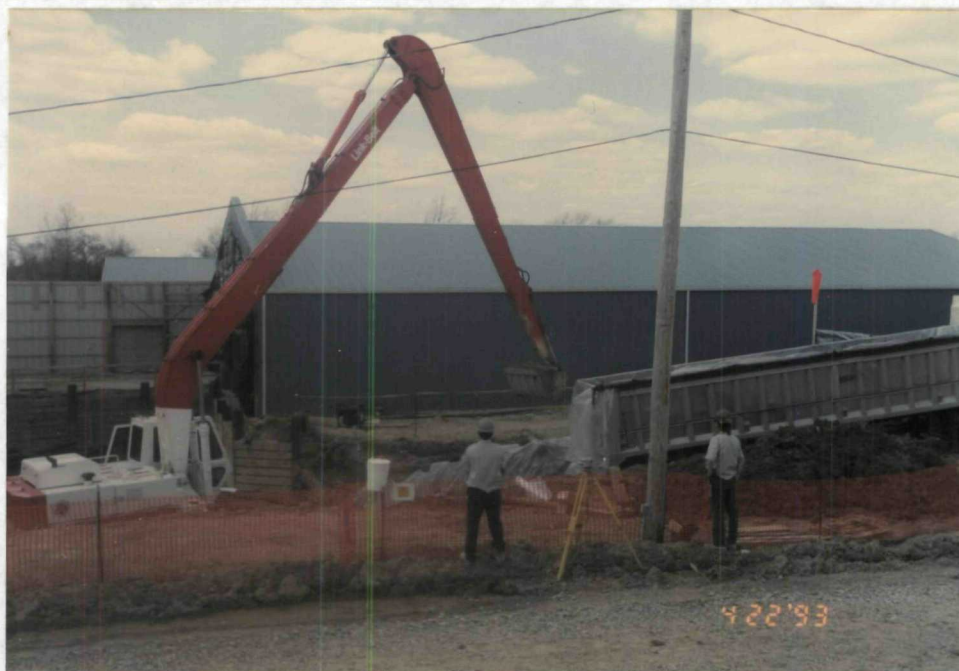
DESCRIPTION: Loading first trailer truck with PCB-contaminated
soil. Note visqueen in place for soil runoff.

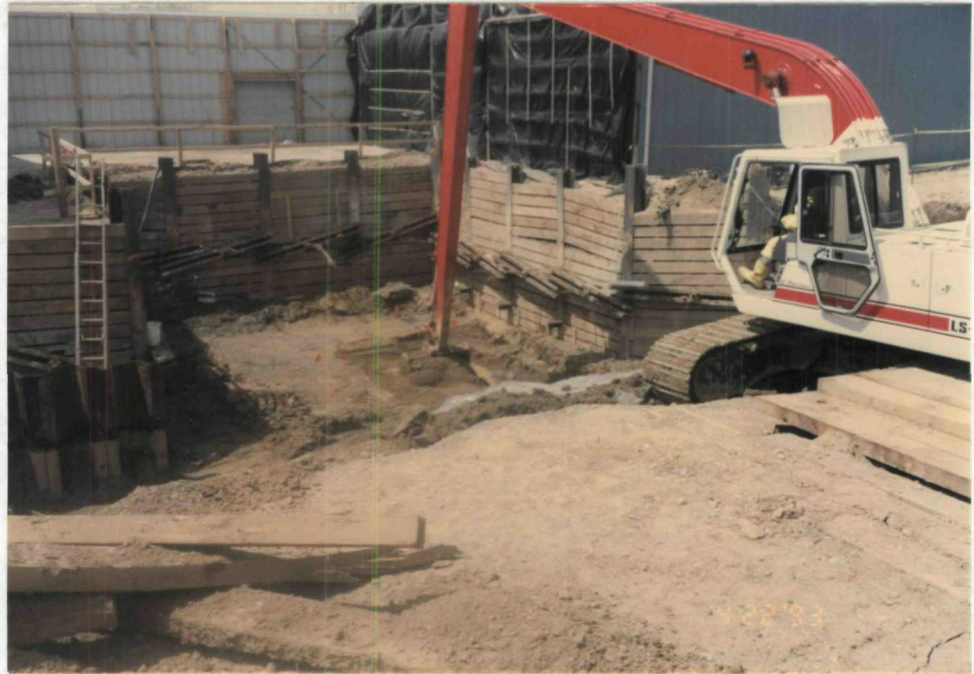
DESCRIPTION: On-going excavation in central portion of
contaminated area (beneath dismantled building).

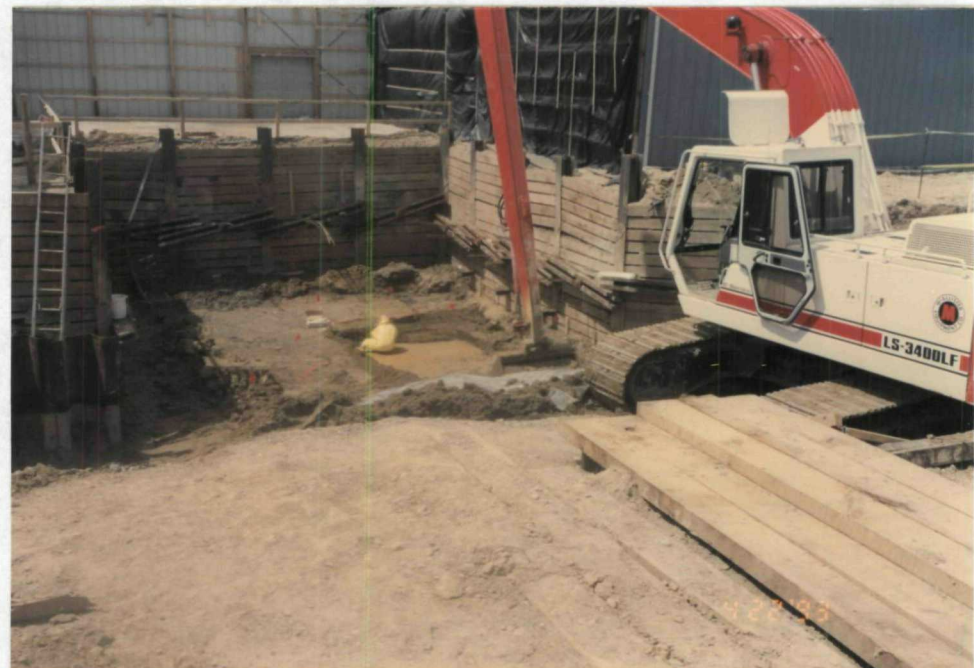
DESCRIPTION: Preparing to collect confirmation sample from west
wall of excavated area. Note water beginning to infiltrate
excavation.

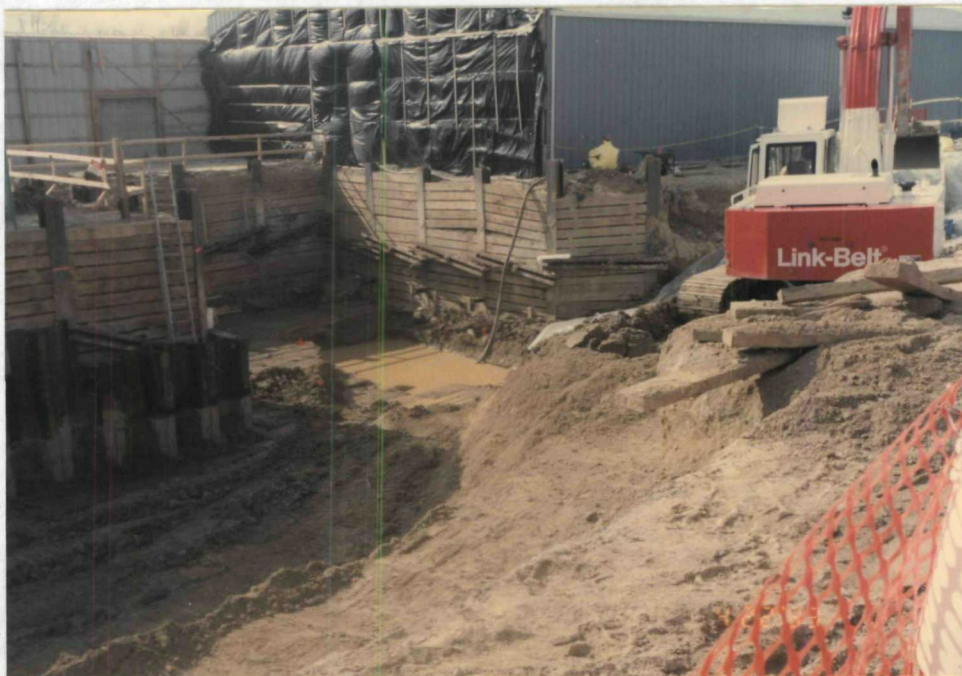
DESCRIPTION: Pumping infiltrate water from excavation pit.

Water pumped into storage tank for disposal at a later date.

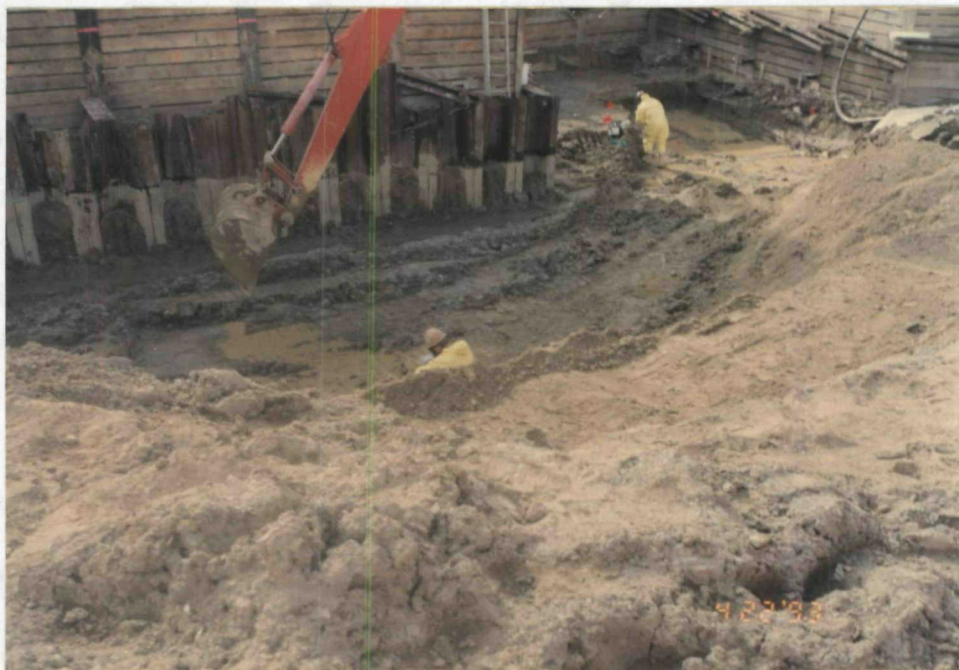
DESCRIPTION: Beginning excavation in southern contaminated area.

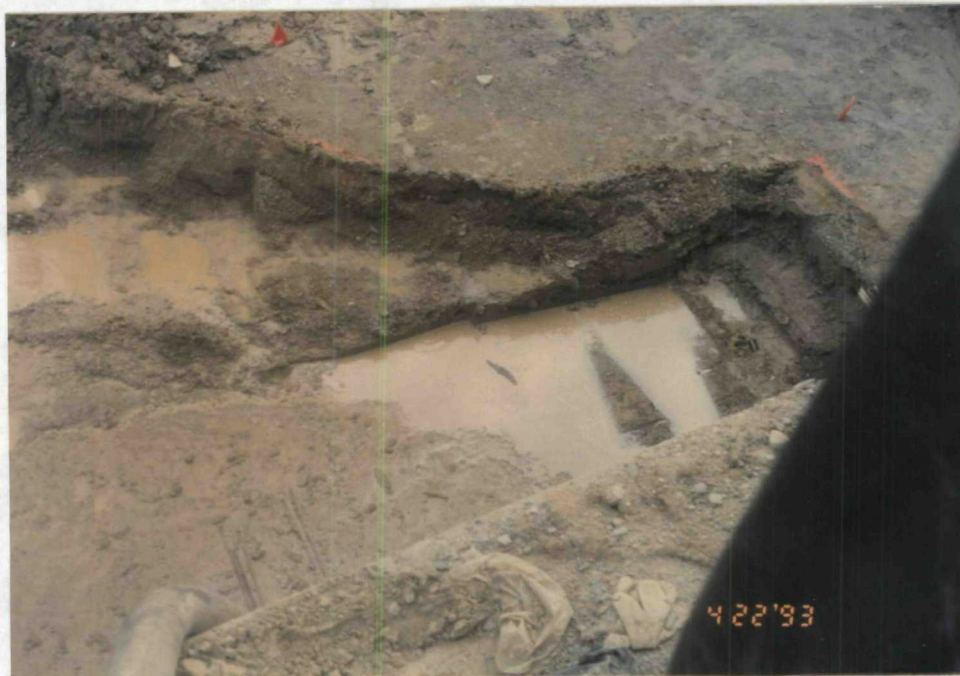
DESCRIPTION: Closeup of excavation area beneath dismantled
building being dewatered.

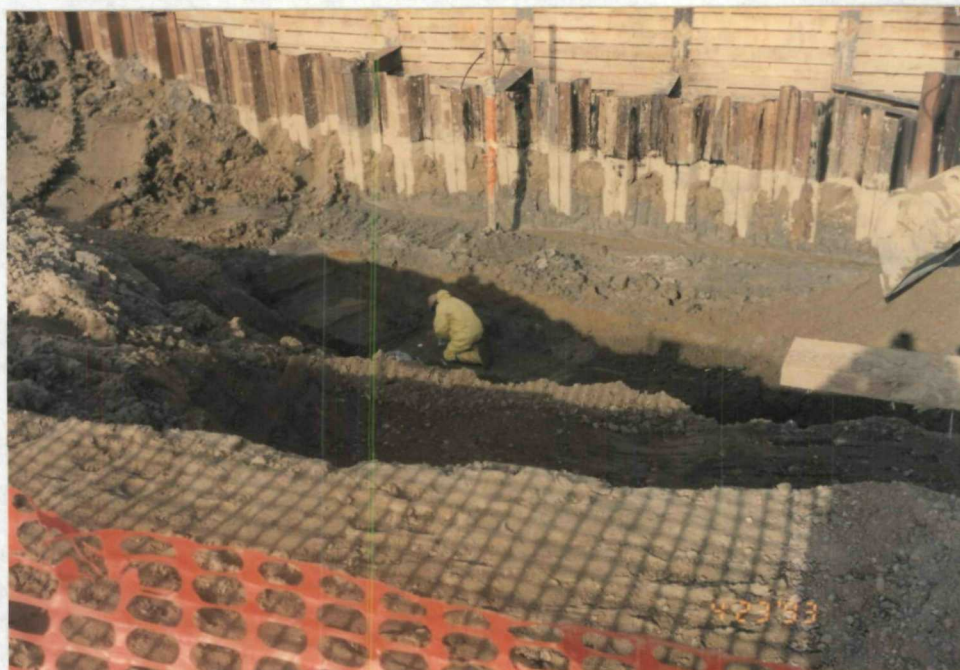
DESCRIPTION: Collecting confirmation sample from southern
excavation area.

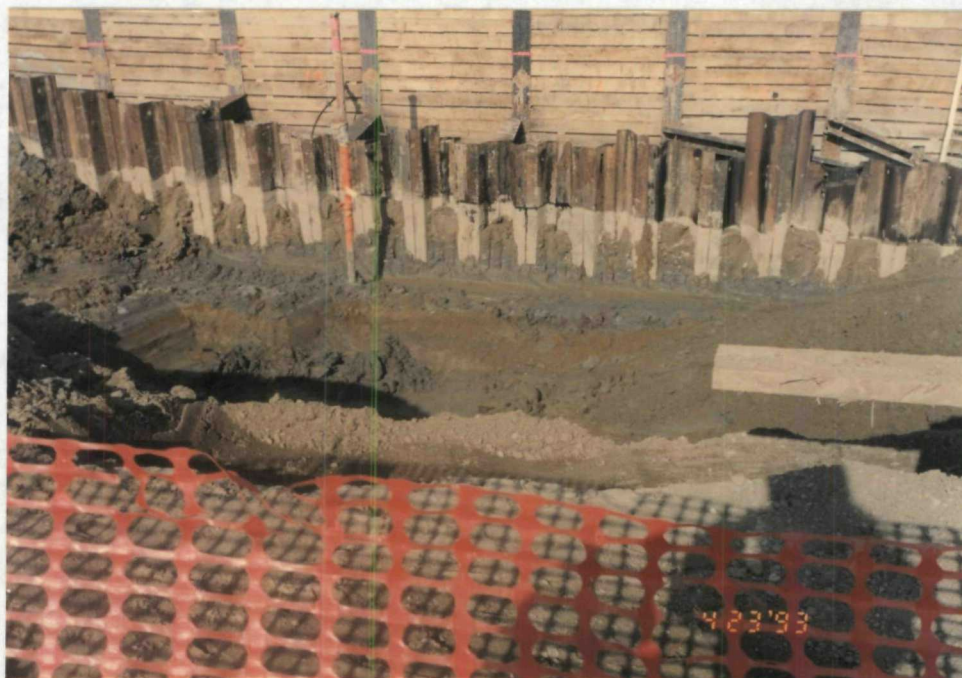
DESCRIPTION: Southern excavation area extended up to western
wall.

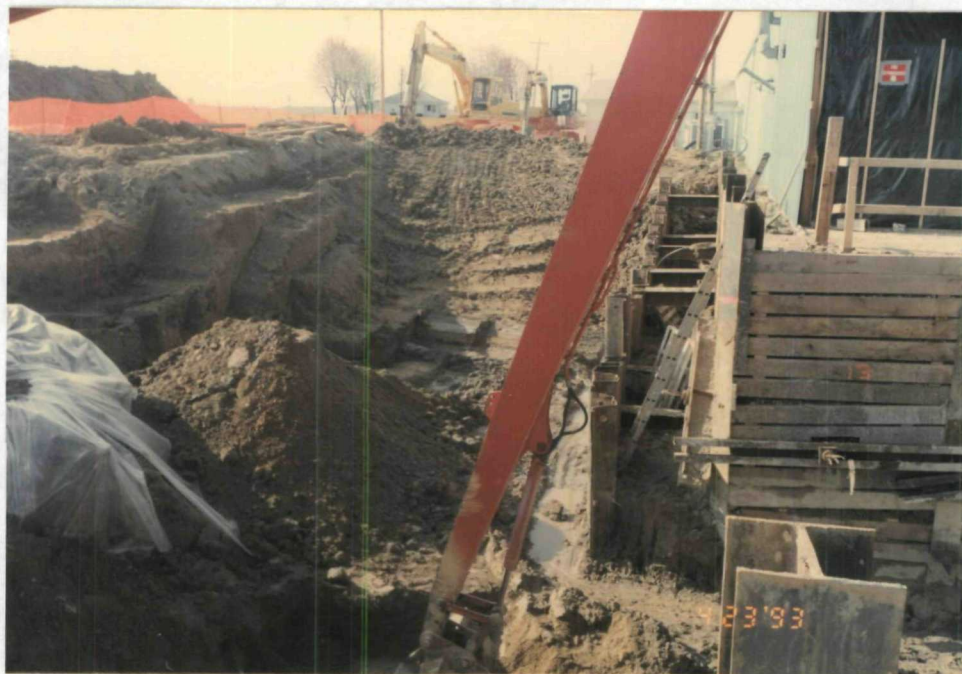
DESCRIPTION: On-going excavation. Note stockpiled contaminated
soil at base of excavation for dewatering.

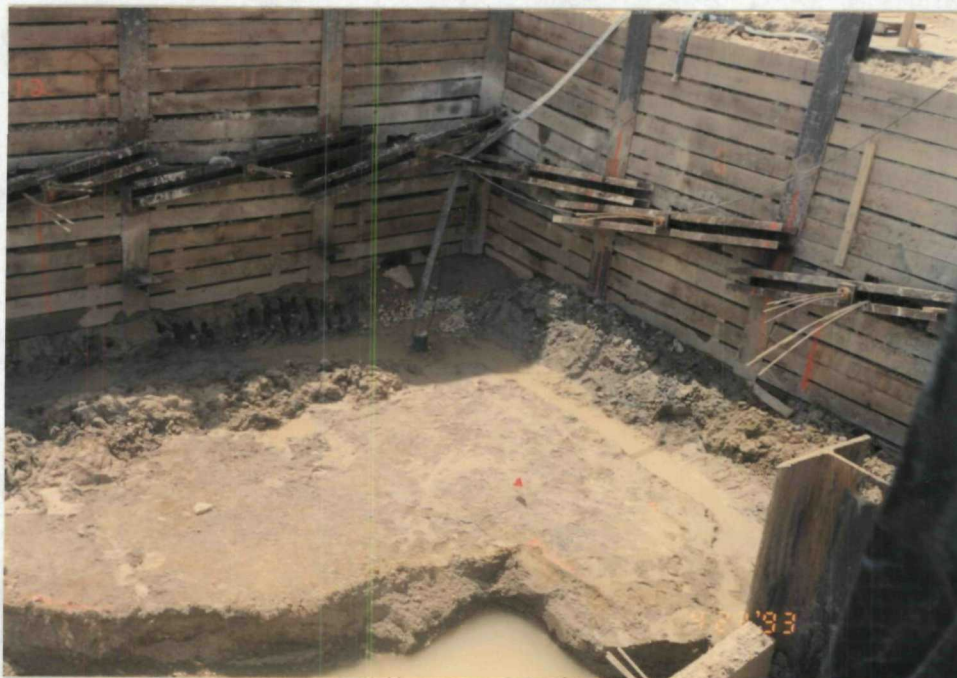
DESCRIPTION: Trench and pump setup around excavation area for
dewatering purposes.

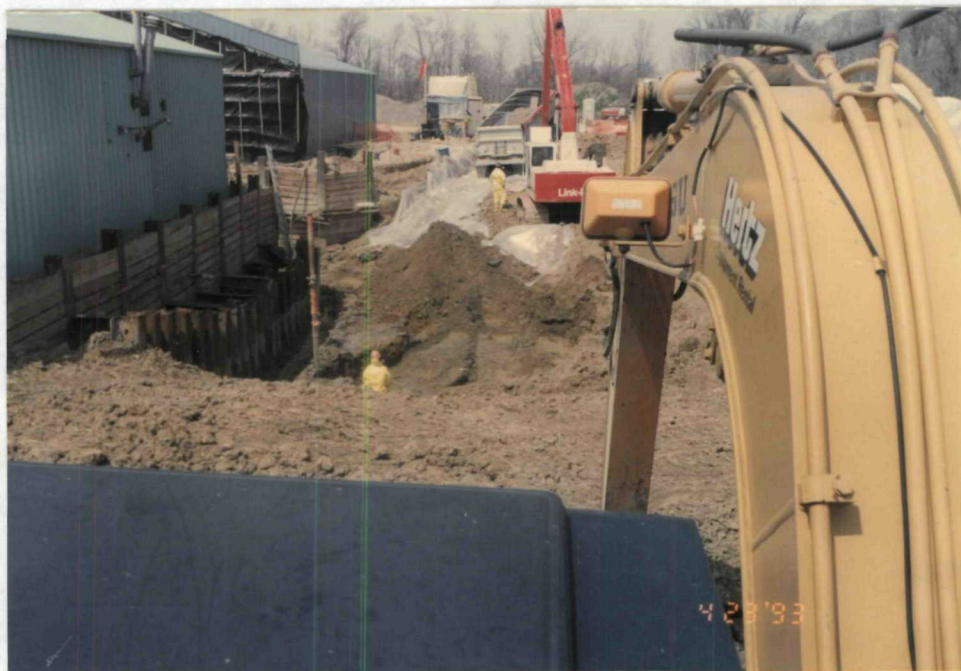
DESCRIPTION: Excavation activity overview.

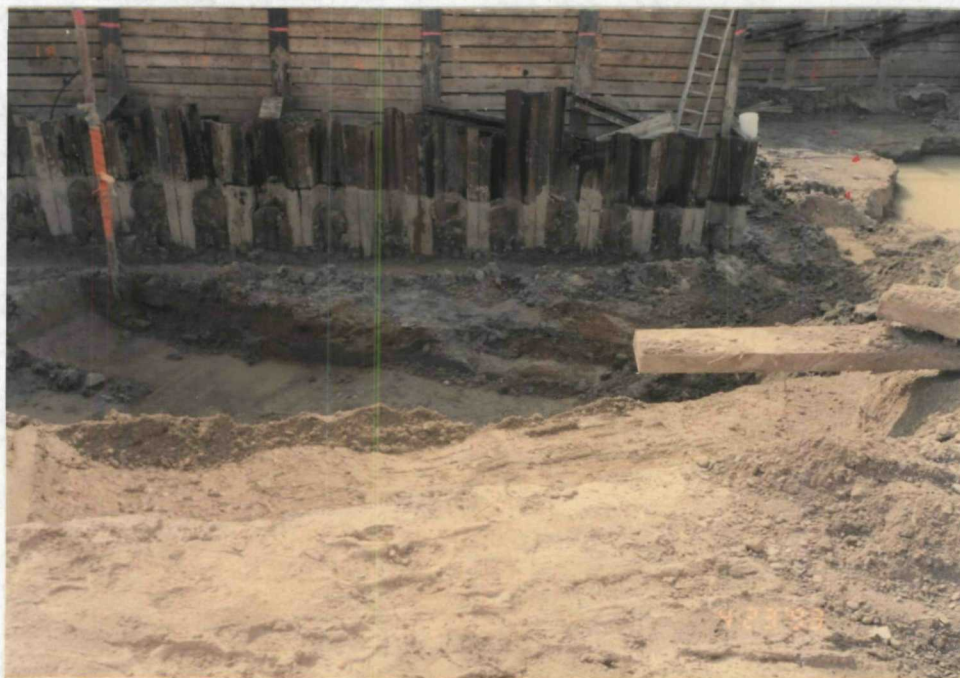
DESCRIPTION: Final excavation in southern area. Note trench
along sheet pile to collect surface water.

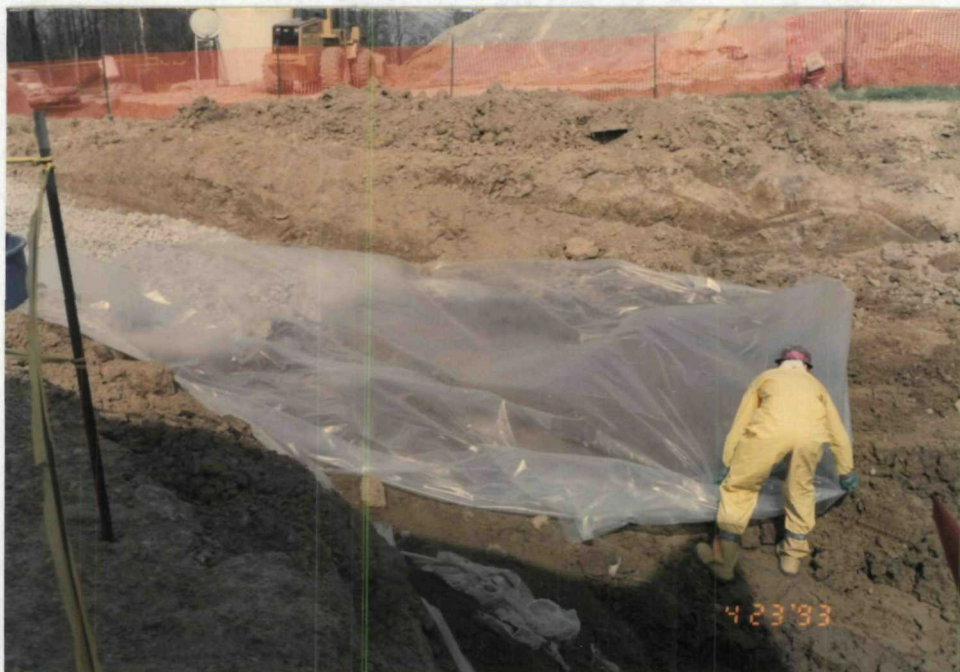
DESCRIPTION: Preparing visqueen on trailer truck path (to catch
any spilled contaminated soil during loading).

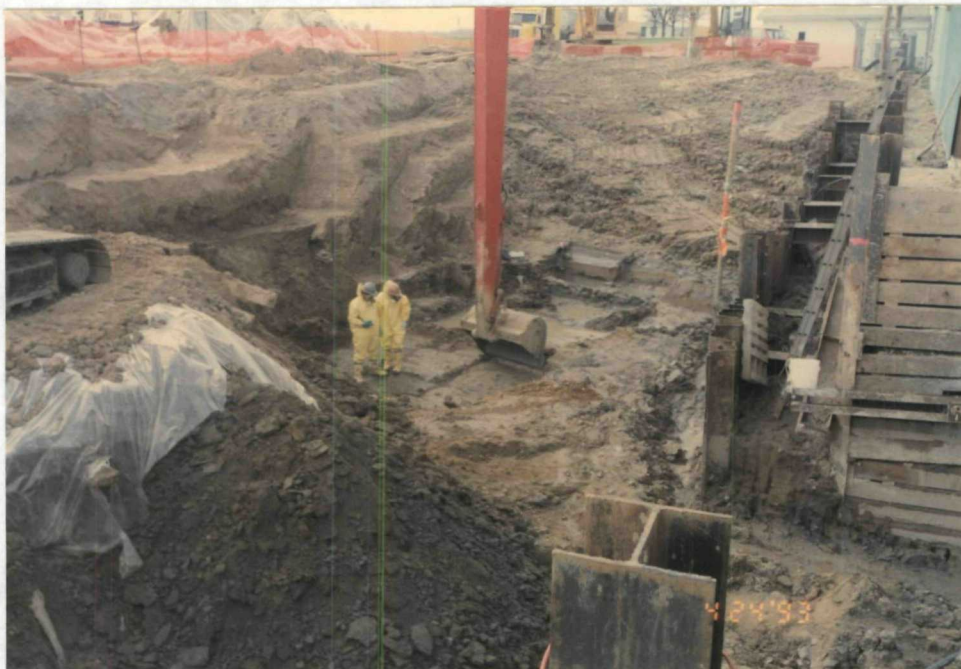
DESCRIPTION: On-going excavation in central area.

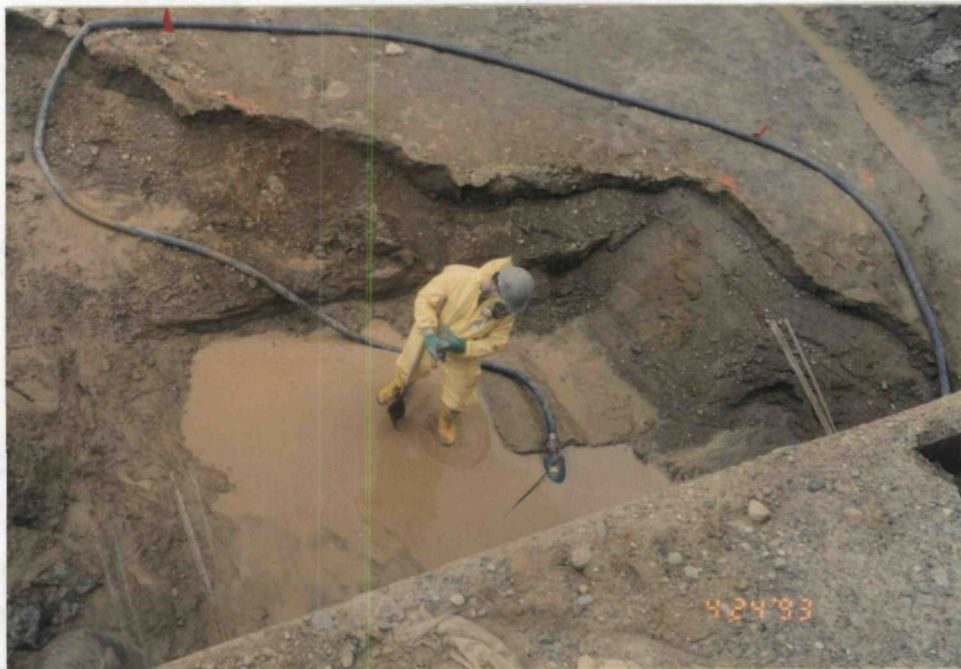
DESCRIPTION: Preparing to backfill excavated area beneath
dismantled building as dewatering.

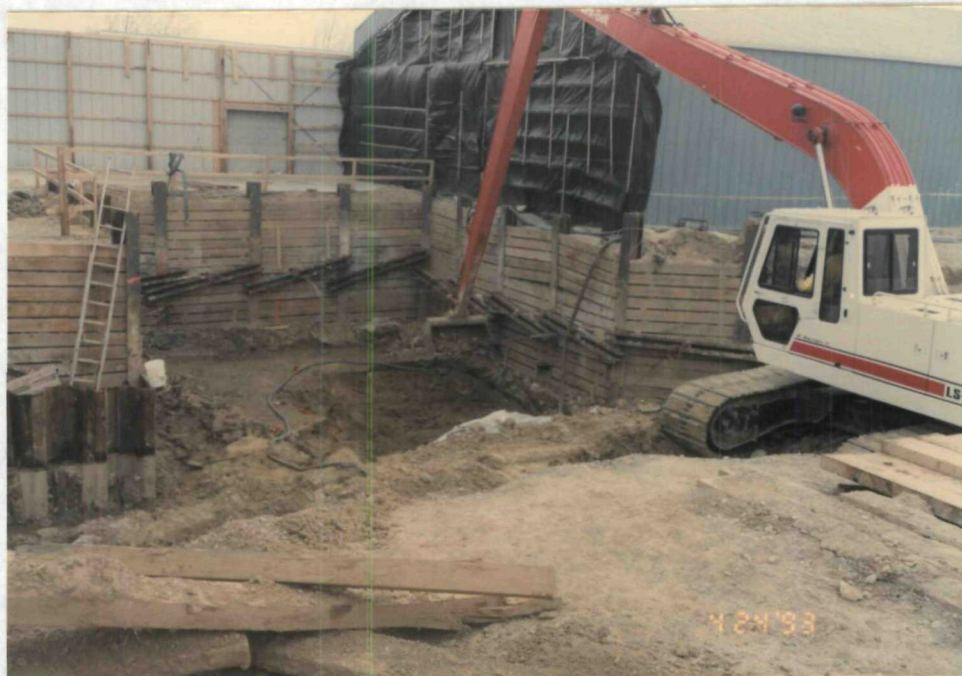
DESCRIPTION: Backfilling central excavation area beneath
dismantled building.

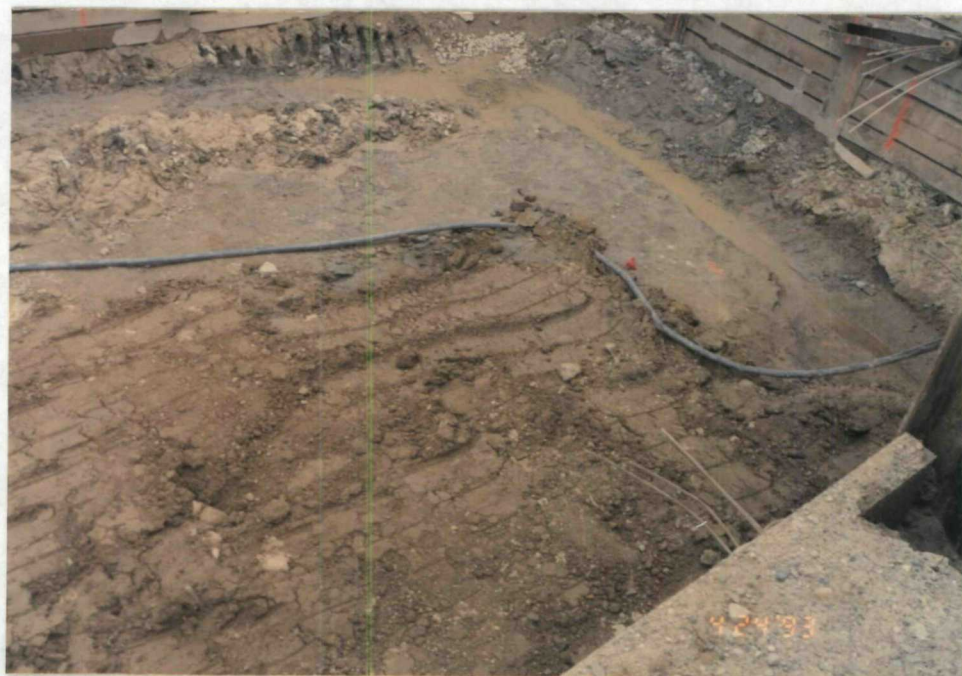
DESCRIPTION: Backfilled area beneath dismantled building
completed.

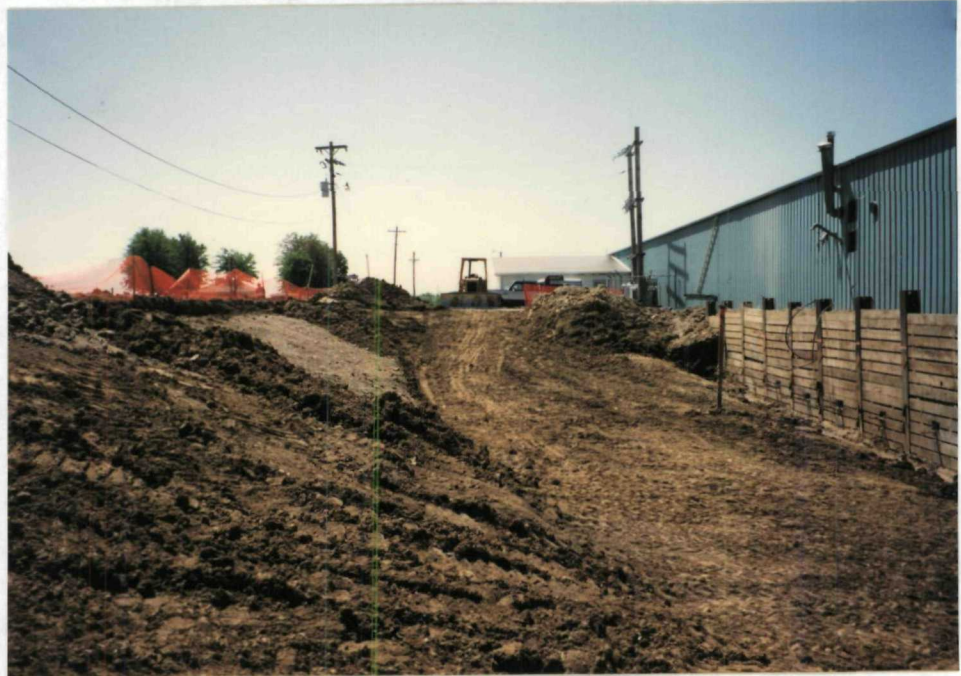
DESCRIPTION: Backfilling progress. Currently approximately
8 feet below grade in southern excavation area.

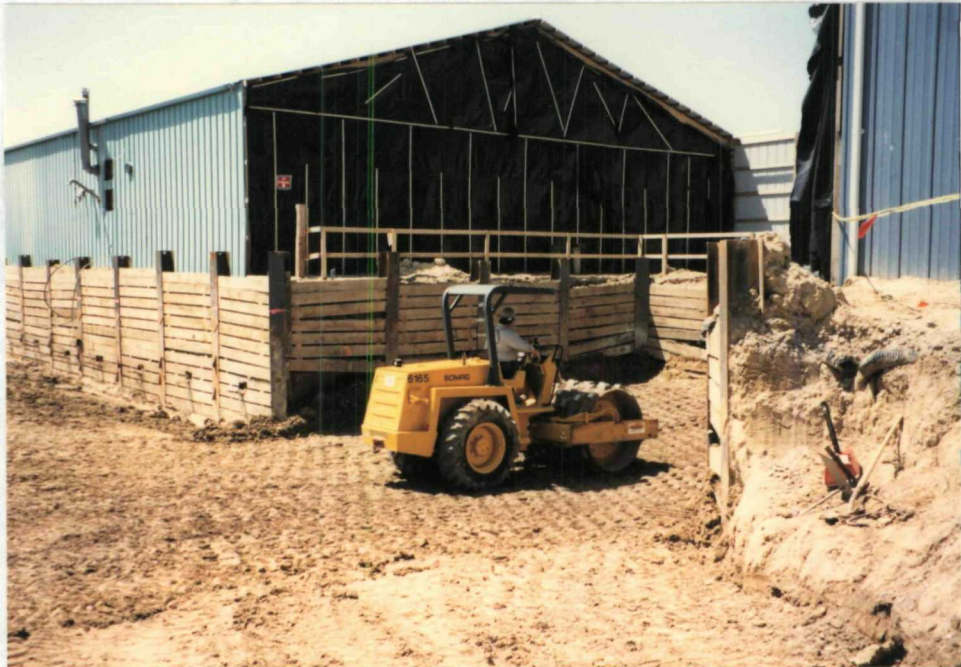
DESCRIPTION: Backfill progress in northern and central
excavation areas. Note compactor in use.

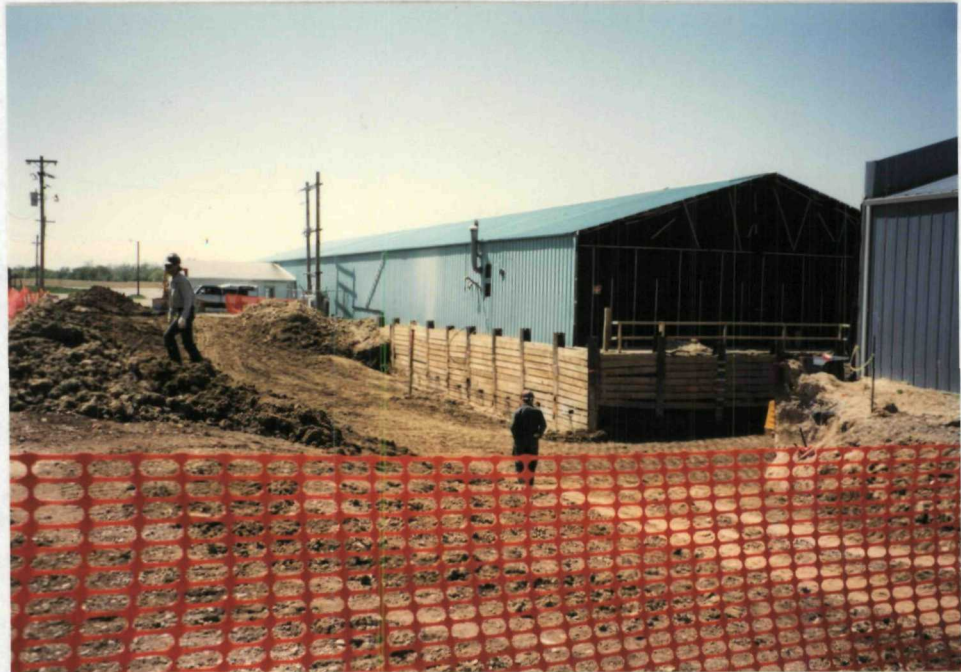
DESCRIPTION: Overview of excavation area and backfilling
progress.

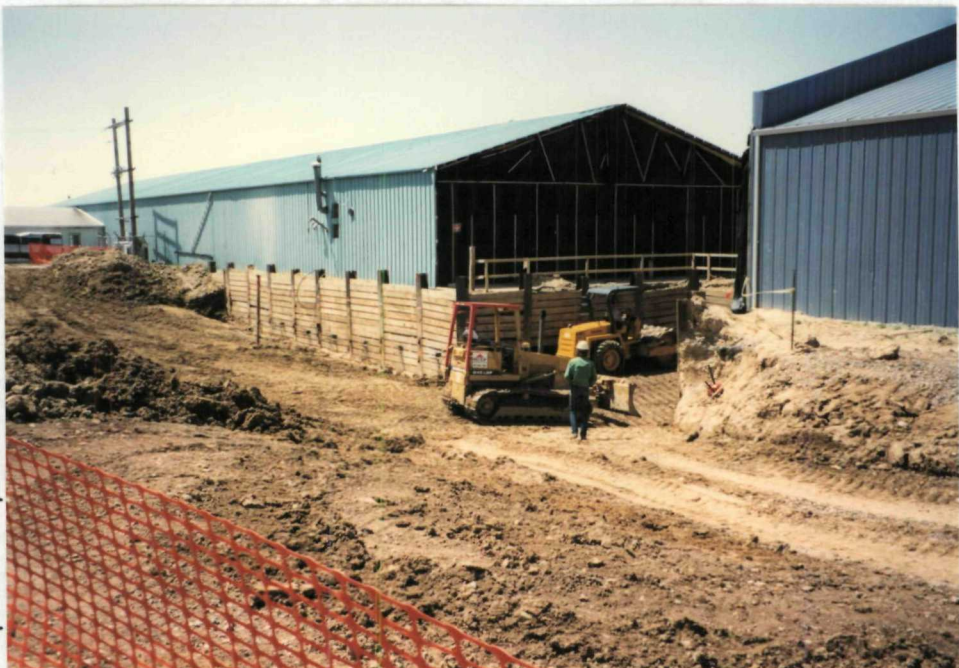
DESCRIPTION: Continuing to backfill and smooth out excavation
area.

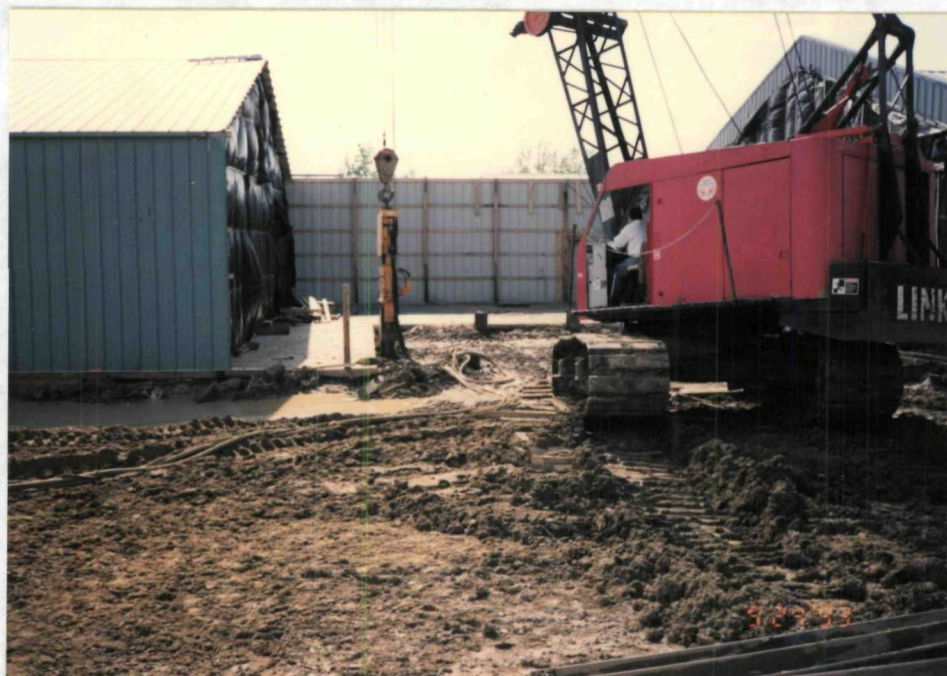
DESCRIPTION: Using crane and vibrator to remove sheet pilings.

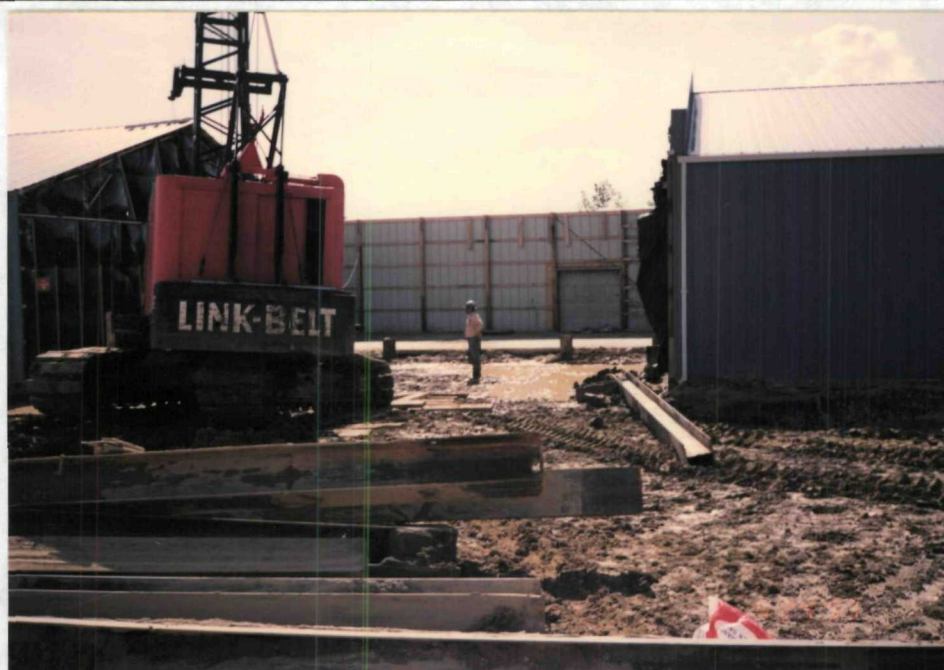
DESCRIPTION: Stacked pile of previously removed sheet pilings.

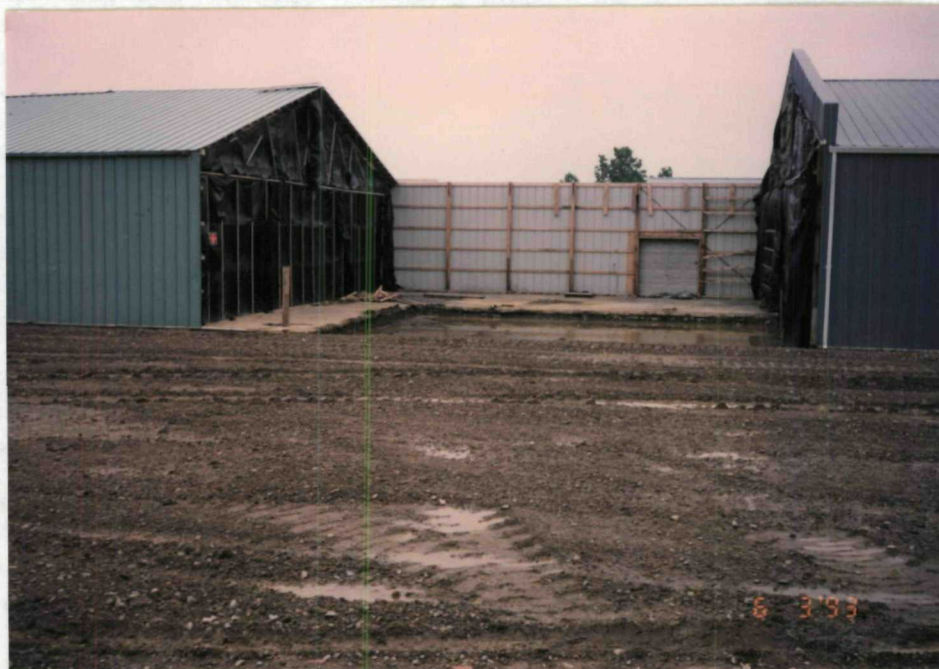
DESCRIPTION: Dismantled area prepared for future building
reconstruction.

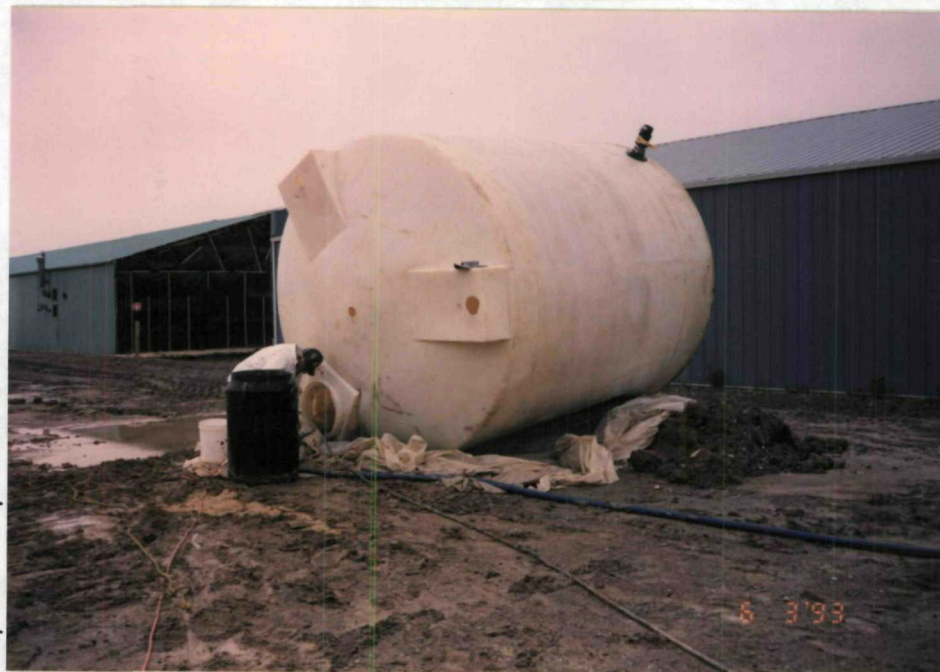
DESCRIPTION: Removing sludge and deconning poly wastewater tanks.

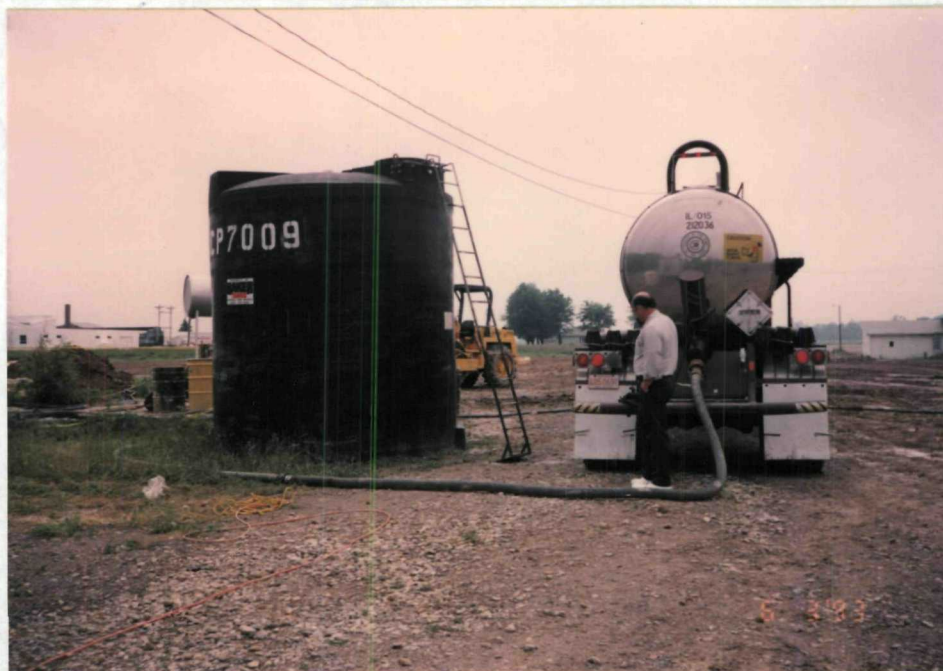
DESCRIPTION: Pumping wastewater into tanker truck for disposal.

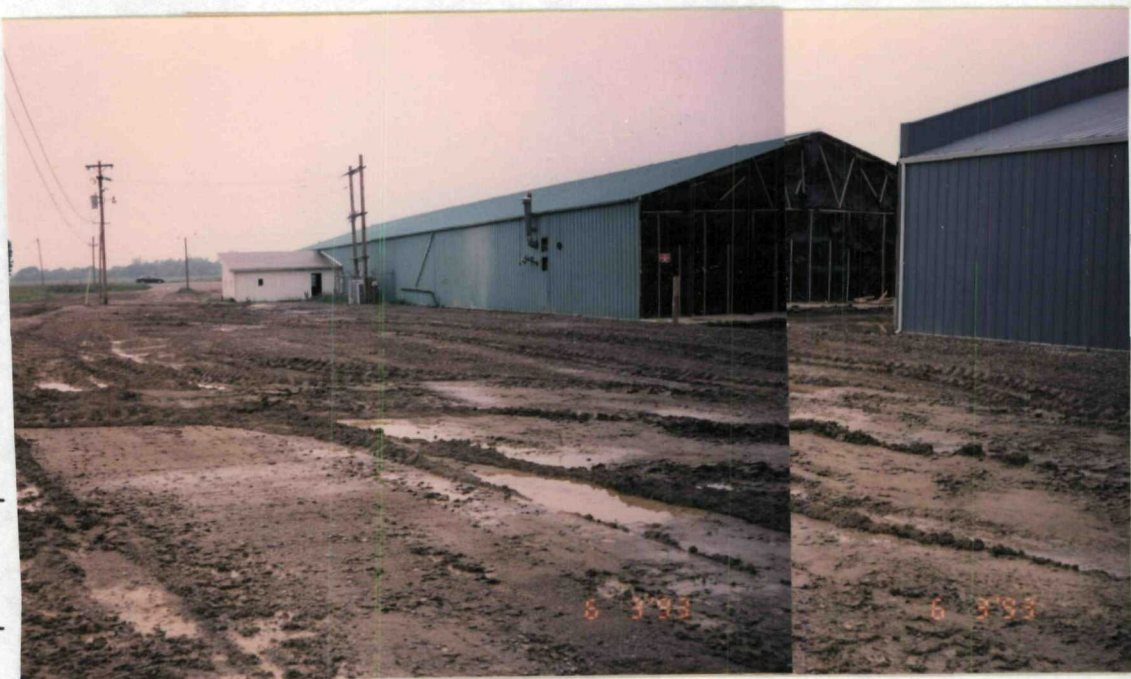
DESCRIPTION: Overview of backfilled excavation areas.

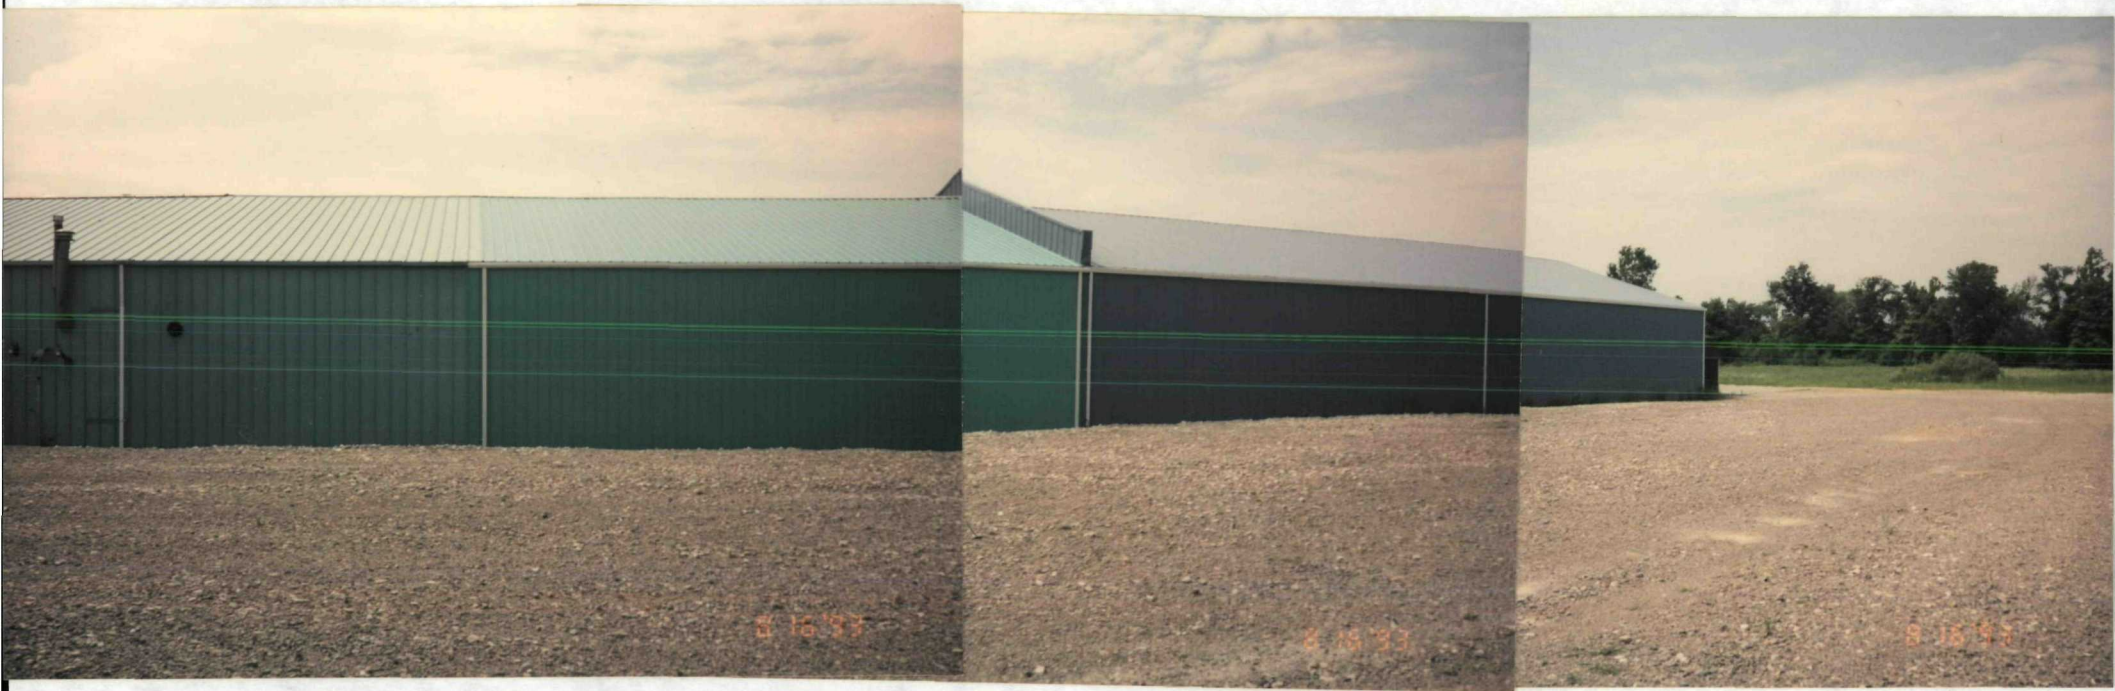
DATE: 8/16/93 TIME: 1400 DIRECTION OF PHOTOGRAPH N/NW PHOTOGRAPHED BY: JASTER
WEATHER CONDITIONS: PARTLY SUNNY, LOW 70s SAMPLE ID (if applicable): N/A
DESCRIPTION: Overview of central portion of site. Note new gravel put in place across traffic areas. Also note reconstucted portion of former Terra building (central aqua portion).
